2.3 Case Histories of Accidental Gas/Vapor Cloud Explosions

2.3.4 The Flixborough Explosion, UK (1974)

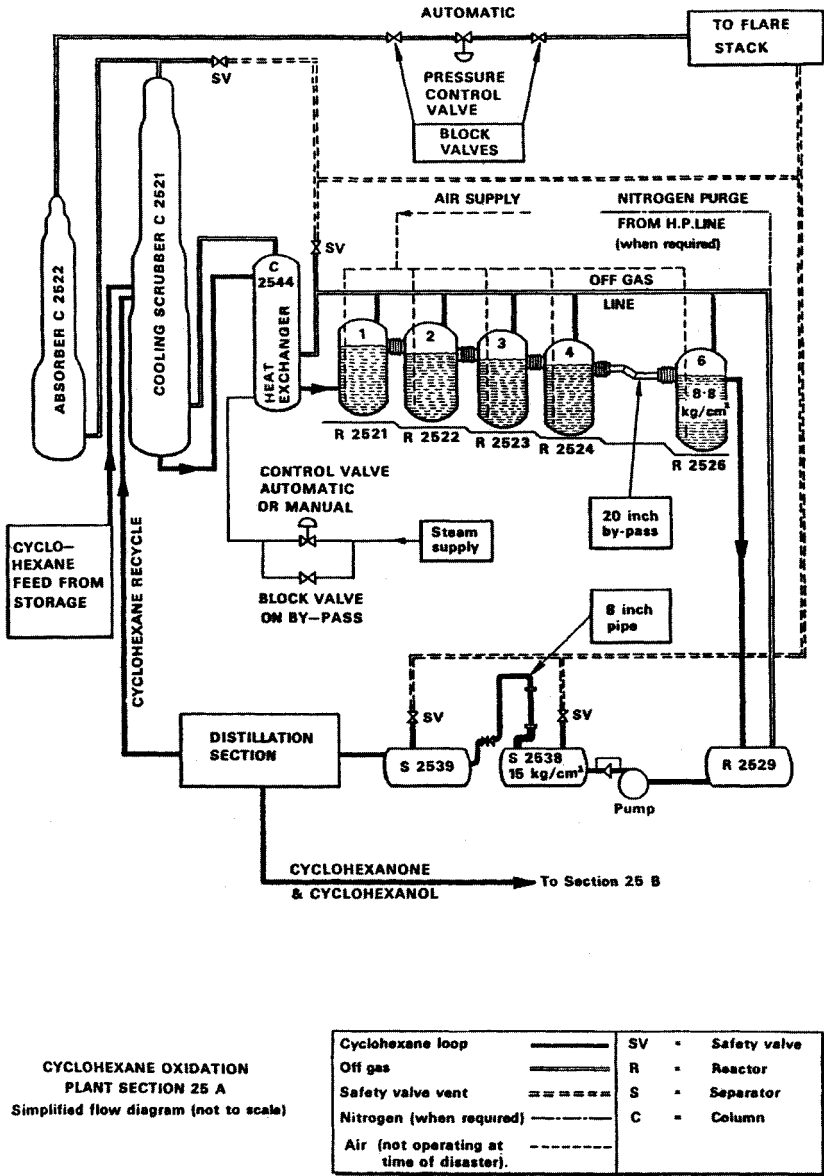
Figure 2-55 Simplified illustration of section 25 A of the cyclo-hexane oxidation plant of the caprolactam production plant at Flixborough. From Parker at al. (1975).

During the late afternoon of the day of the explosion, the provisional 20" bypass system ruptured, without or with a contribution from a fire on a nearby 8" pipe. This resulted in the escape of a very large quantity of cyclo-hexane. The cyclo-hexane formed a vapor cloud (and possibly also a liquid-droplet spray cloud, see Section 3.5.1), and the flammable part of the cloud found a source of ignition. At about 4.53 p.m. there was a huge, catastrophic vapor cloud explosion.

The overall conclusion of the final inquiry was that the disaster was due to "ignition and rapid acceleration of the resulting deflagration, possibly to the point of detonation, of a massive vapor cloud formed by the escape of cyclo-hexane under a pressure of at least 8.8 bar(g) and a temperature of 155 °C, and that the escape was from Section 25A of the cyclo-hexane plant." There was no dispute that the main part of the cyclo-hexane came from the 20" bypass assembly, but there was some uncertainty as to whether the mechanical failure of the assembly was the primary failure or whether it was a secondary failure caused by a preceding one.

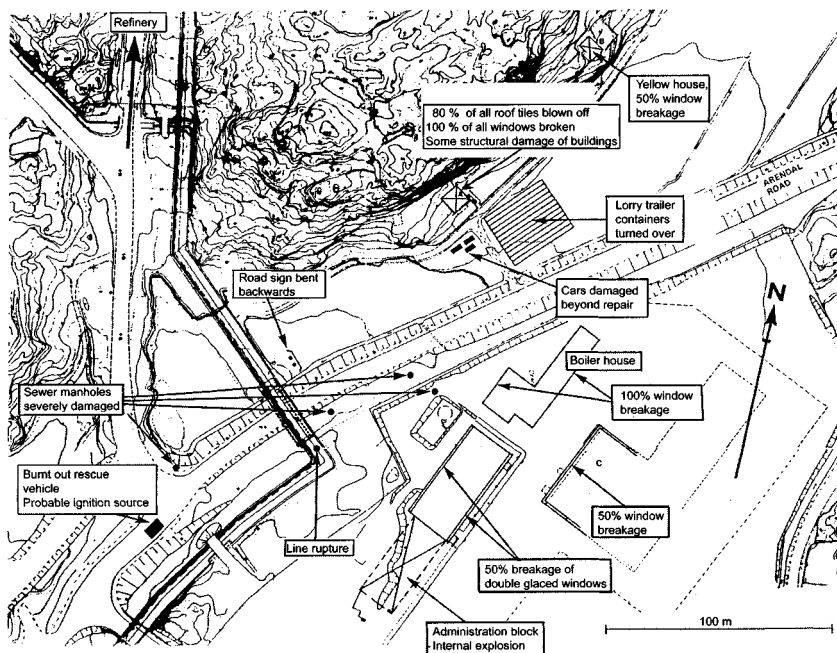
Figure 2-56 Plan of site and consequences of propane vapor cloud explosion at Arendal, Gothenburg, Sweden, in 1981. From Nilsson, 1991.

that was driven into the explosive cloud. There was a series of distinguishable explosions, extending over about thirty seconds. The major fireball had a diameter of 300 m. Maximum explosion overpressures at various locations, e.g. in the sewer manholes indicated in Figure 2-56, were estimated from damage analyses.

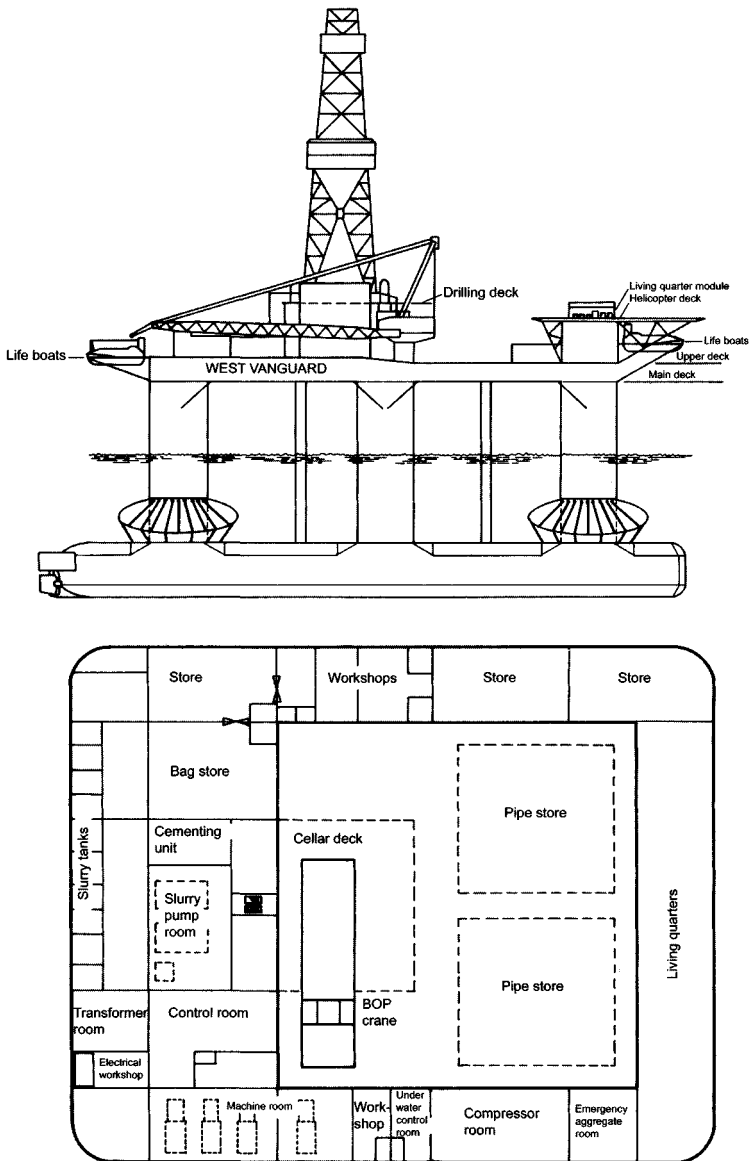
Figure 2-57 Illustration of the mobile drilling platform 'West Vanguard', with a side view of the entire platform, and a top view of the main deck. The main deck is 85 m long and 75 m wide. The platform was kept floating by means of two 100 m long pontoons. From Public Commission of Investigation (1986).

At least two distinct explosions were heard. The first and most powerful produced a large flameball in the area of the drilling tower and across the pipe deck. According to most witnesses, this explosion probably occurred in the cellar deck. The second major explosion probably occurred in the engine room about one minute after the first explosion. Fortunately, as soon as the blow-out got out of control, and only a few minutes before the first explosion, the rescue operation had started, and 79 of the 80 persons on board were able to get into the lifeboats from which they were picked up by the standby ship before the explosion occurred. Large amounts of natural gas were bubbling through the sea to the sea surface, and from the stand-by ship it was observed that natural gas was burning across the sea surface in some areas around the platform, but fortunately not in the area from which the people were rescued. The platform suffered severe damage from the explosions and subsequent fires, mainly in the after part, including the area around the drilling tower and the adjacent areas and rooms. Roofs, bulkheads and bolted steel doors were blown up or heavily deformed by the explosion pressures.

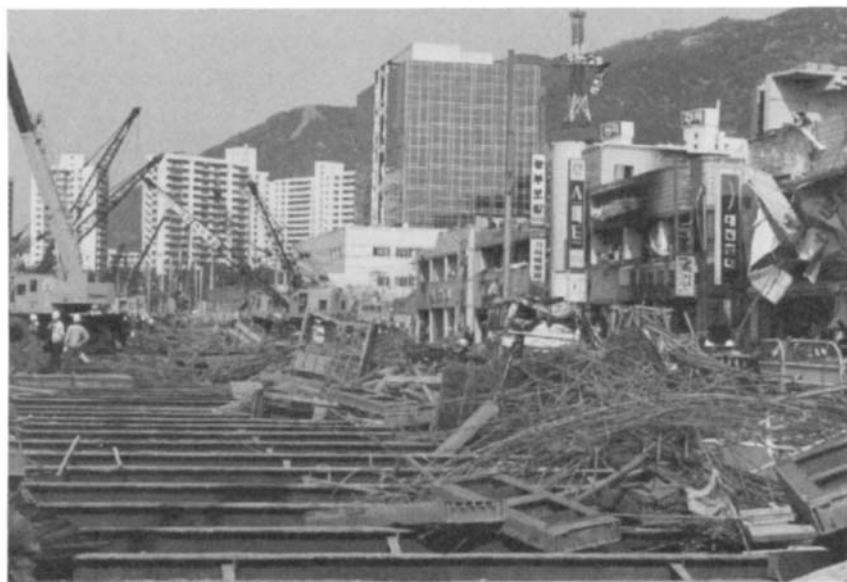
Figure 2–58 Site of the LPG explosion disaster in Taegu, South Korea, April 28, 1995, which killed 100 people, and injured 117. Ten buildings were completely demolished and 48 others partly damaged, while 80 vehicles were destroyed or damaged.
From Fire Investigation Report (1995).

were flung into the air. One of these, weighing 280 kg (270 cm × 70 cm × 2 cm), was found hanging on a church cross on top of a three-story building near the explosion site. The explosion severely deformed and displaced the heavy duty H-beams supporting the provisional road cover within 1 km of the explosion centre. This caused numerous other steel plates to collapse under the load of all the vehicles, and thirty cars and buses were plunged into the 18 m deep construction cavity. Other cars soared to 10 m above road level. In all, eighty vehicles were damaged by the explosion. Ten buildings were completely demolished and forty-eight others partly damaged. Gas pipelines, water pipes, and underground cable pits were also destroyed, and the whole area was flooded, and the electrical power was cut off in thousands of homes. Rescuers found 97 people killed, three people missing, and 117 people injured.
