## 5.4 Case Histories of Dust Explosions

### 5.4.1 Motivation for Selection

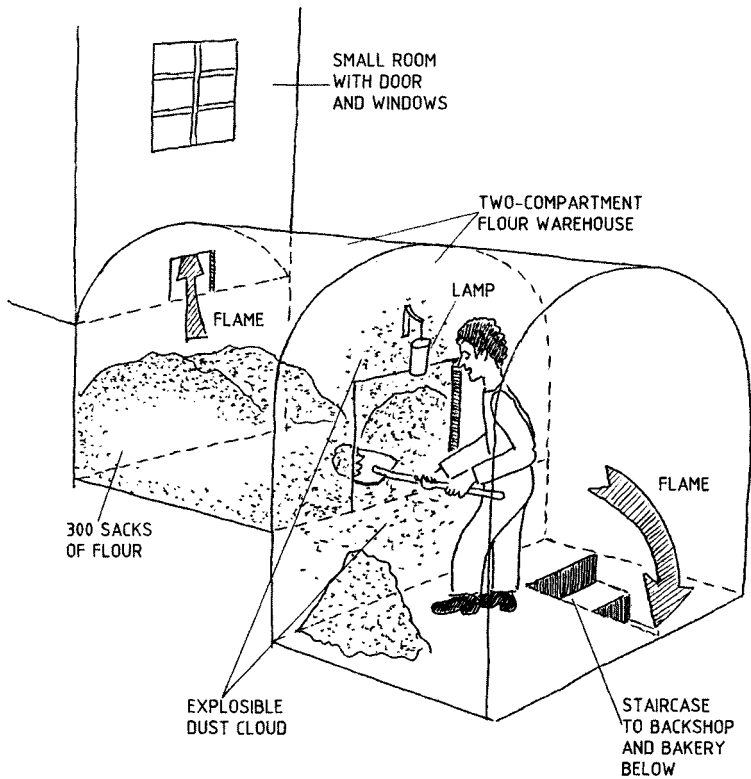
**Figure 5-41 Reconstruction of possible scene of wheat flour explosion in Mr. Giacomelli's bakery in Turin, Italy, on 14th December, 1785, as described by Count MoroZZo (1795). (From Eckhoff, 2003).**

took place, followed by a thick cloud, which immediately caught fire, from the lamp hanging to the wall, and caused the violent explosion here treated of.

The baker told me that he had never had flour so dry as in that year (1785), during which the weather had been remarkably dry, there having been no rain in Piedmont for the space of five or six months: indeed, he attributed the accident which had happened in his warehouse to the extraordinary dryness of the corn.

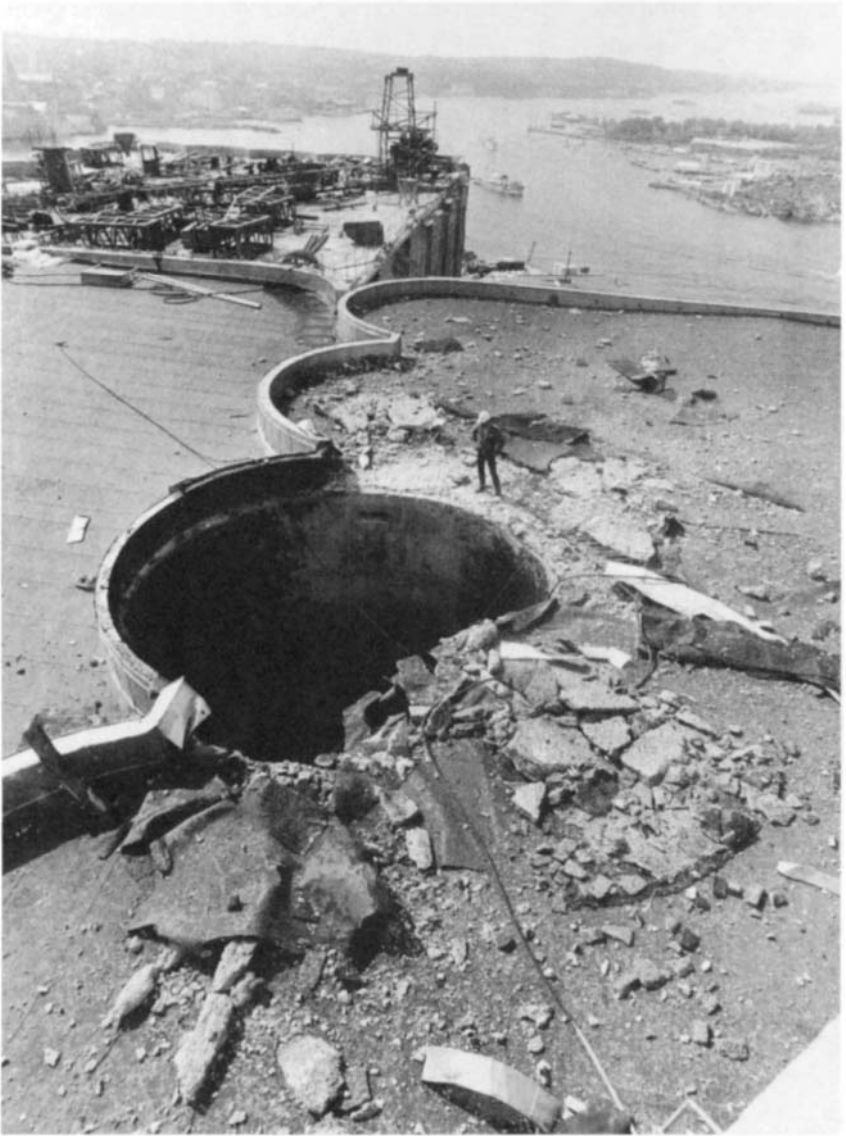
Almost all the windows, except those in the office department, were blown out, as was a large provisional light wall at the top of the head house. The legs of all of the five bucket elevators of 0.65 m × 0.44 m cross-section were torn open from bottom to top. The dust extraction ducts were also in part torn open.

The ignition source and its location were never fully identified. However, two hypotheses were put forward. The first was self-ignition of dust deposits in the boot of a bucket elevator in which the explosion was supposed to have started. The self-ignition process was initiated by a bucket that had been heated by repeated impacts until it finally loosened and fell into the dust deposit in the elevator boot. The second hypothesis was that the chain of events leading to ignition started with welding on the outside of the grain feeding duct leading to one of the elevator boots. The situation is illustrated in Figure 4–8. Due to efficient heat transfer through the duct wall, self-heating could have been initiated in a possible dust deposit on the inside of the duct wall. Lumps of the smoldering deposit could then have loosened and subsequently become conveyed into the elevator boot, initiating an explosion in the dust cloud there.

**Figure 5-42** Damaged silo roof after the wheat grain dust explosion in Stavanger in June 1970. From Eckhoff (2003).

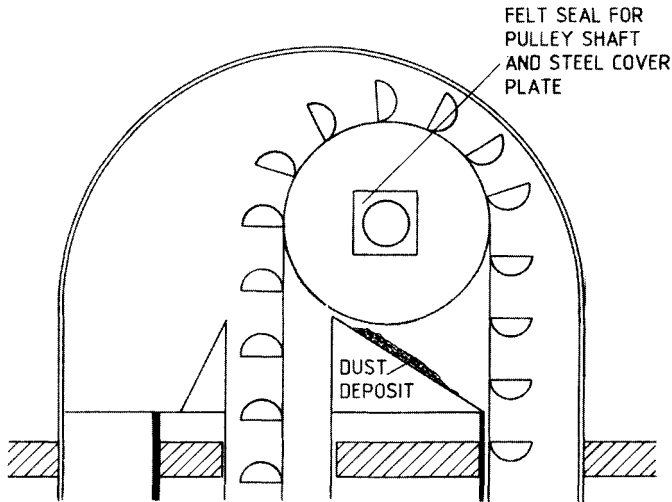
The explosion occurred in a bucket elevator head immediately after termination of transfer of Norwegian wheat grain between two silo cells. At the moment of explosion the transport system was free of grain. In this new part of Stavanger Port Silo, the bucket elevator legs are cylindrical and mounted outdoors, along the wall of the head house. A number of vents are located along the length of the legs. In the explosion incident the vent covers on the elevator leg involved were blown out, which undoubtedly contributed to reducing the extent of the explosion. There was no significant material damage, either by pressure or by heat. Figure 5-43 illustrates the head of the bucket elevator in which the explosion occurred.

Because of a slight offset, the steel cover plate for the felt dust seal for the pulley shaft touched the shaft and became heated by friction during operation of the elevator. The hot steel plate in turn ignited the felt seal, from which one or more glowing fragments dropped into the wheat grain dust deposit on the inclined surface below, initiating smoldering combustion in the deposit. Just after the elevator had stopped, there was presumably still enough dust in the air to be ignitable by the smoldering dust, and to be able to propagate a flame. Alternatively, some of the smoldering dust may have slid down the inclined surface and become dispersed and transformed into an exploding dust cloud. Just after the explosion, some smoldering dust was still left on the inclined plate below the elevator pulley.

**Figure 5-43** Schematic illustration of head of a bucket elevator in the new part of Stavanger Port Silo, where the minor 1988 wheat grain dust explosion was initiated. Courtesy of O. Olsen, Stavanger Port Silo, Norway.

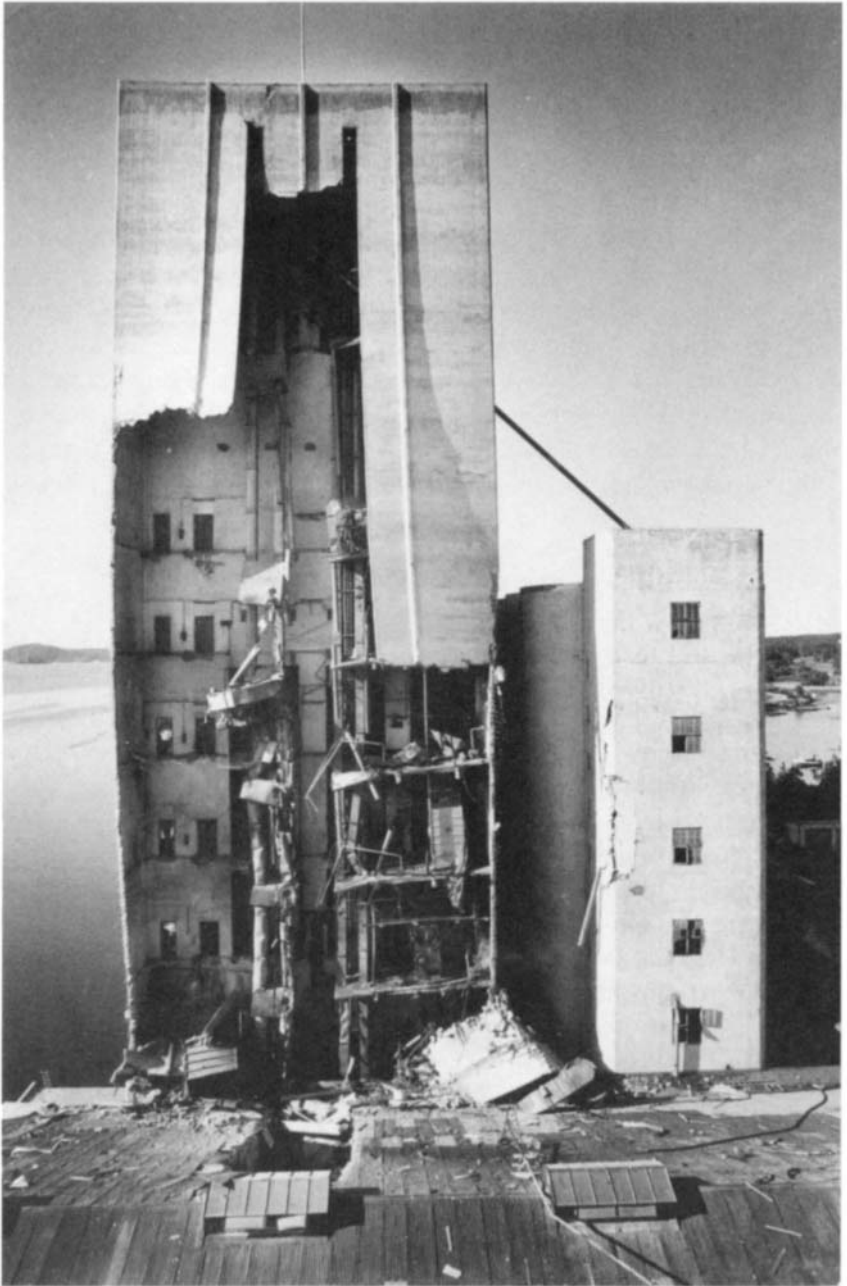
The explosion probably started in a bucket elevator, initiated by burning/glowing material from an overheated hammer mill. The primary explosion developed into a secondary explosion in the head house itself, which pushed out most of its front wall, as shown in Figure 5-44.

Two of the bucket elevators had bulged out along the entire length and the dust extraction ducting had become torn apart, and this gave rise to the secondary explosion. Because the floors were supported by the wall, and the connections between wall and floors were weak, the entire wall sheet was pushed out at a quite low explosion pressure, leaving the floors unsupported at the front.

**Figure 5-44** Damaged silo head house after a grain dust explosion at Kambo, Norway, in June 1976. Courtesy of Scan Foto, Oslo, Norway.

After the explosion, the head house was reconstructed. The floors were supported by a rigid framework, and should an explosion occur again, the lightweight wall elements can serve as vent covers, without weakening the support of the floors.

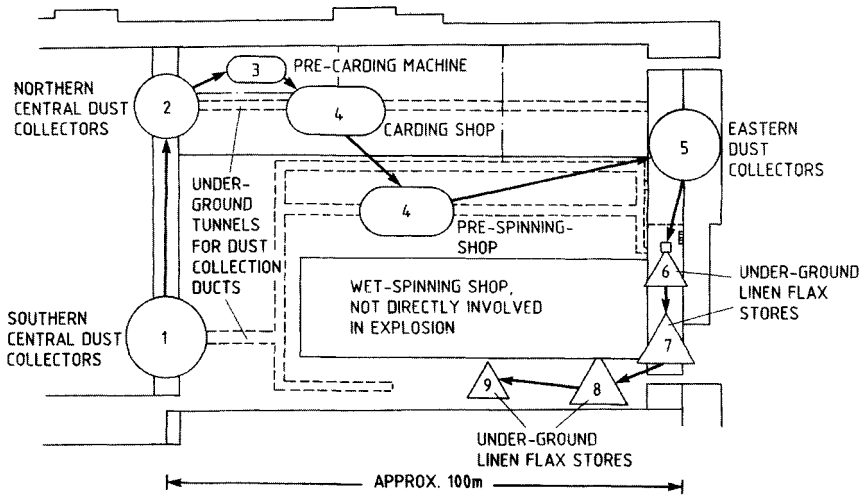
Figure 5–45 illustrates the 13,000 m<sup>2</sup> spinning section through which the explosion swept, and the possible locations and sequence of the nine successive explosions that comprised the event according to Xu Bowen (1988) and Xu Bowen et al. (1988). These workers based their reconstruction of the explosion on three independent elements of evidence. First, they identified the location of the various explosion sites throughout the damaged plant. Secondly, they ranked the relative strengths of the local explosions by studying the extent and nature of the damage. Thirdly, they arranged the various local explosions in time by means of the relative strengths of the nine successive explosions, identified by decoding the seismic recording of the event.

**Figure 5-45** Schematic illustration of the 13, 000 m<sup>2</sup> spinning section of the Harbin Linen Textile Plant, P.R. China, that was afflicted with a catastrophic dust explosion on 15 March 1987. Numbered circles, ovals and triangles indicate location and sequence of a postulated series of nine successive explosions. From Eckhoff (2002).

ducting. On the basis of his analysis, Zhu suggested that the explosion was initiated in the eastern dust collectors (5) indicated in Figure 5–45, from which it transmitted to the nine units of the central dust collecting plant (1) and (2) via the ducting in the underground tunnels. Severe room explosions were initiated when the ducting in the tunnel ruptured, and the resulting blast dispersed large quantities of dust in the workrooms into explosive clouds that were subsequently ignited. From the eastern dust collectors the explosion also propagated into the underground flax stores.

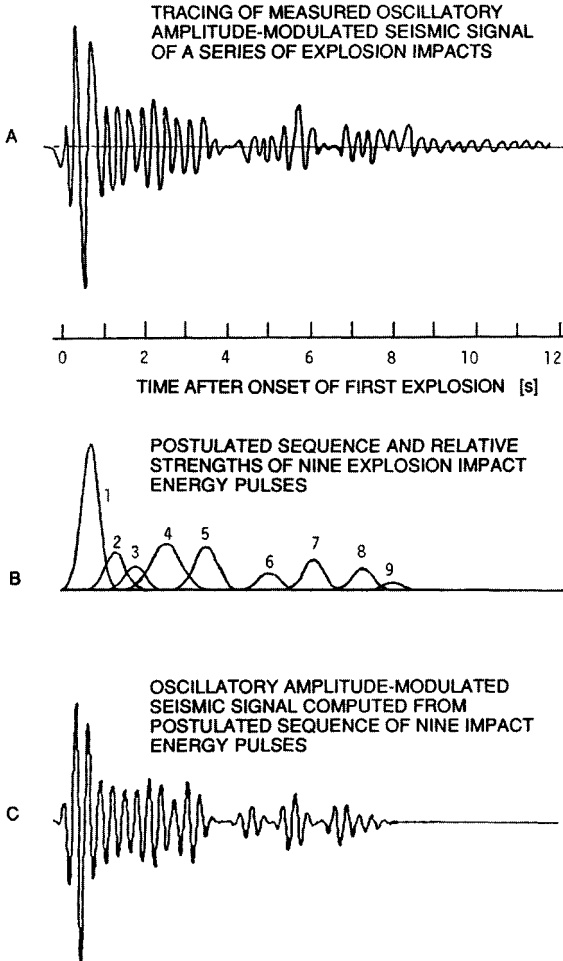
Figure 5–46(a) shows a direct tracing of the amplitude-modulated seismic signal actually recorded 17 km from the explosion site. Figure 5–46(b) shows the sequence of nine energy pulses impacting on the earth at the location of Harbin Linen Textile Plant, deduced from the signal in (a). Finally, Figure 5–46(c) shows the theoretical prediction of the seismic signal to be expected from the sequence of explosions in Figure 5–46(b). The agreement between the (a) and (c) signals is striking, which supports the validity of the postulated energy impact pulse train (b).

**Figure 5-46** Sequence of nine impact energy pulses from nine successive dust explosions in the Harbin Linen Textile Plant, Harbin, P.R. China, 15 March 1987, postulated on the basis of a seismic record of the event. From Eckhoff (2000).

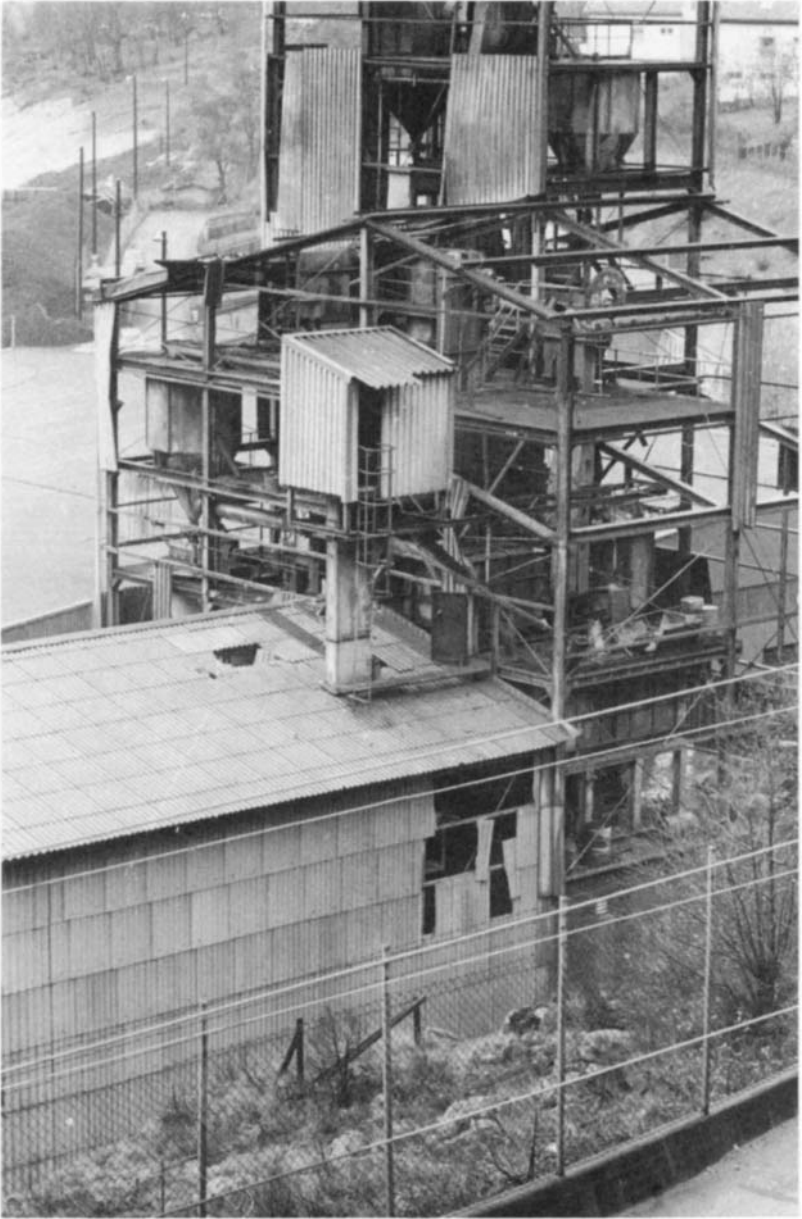
The investigation after the accident disclosed a small hole in a steel pipe for conveying silicon powder from one of the mechanical sieves to a silo below. An oxygen/acetylene cutting torch with both valves open was

**Figure 5-47** View of the extensive demolition of the silicon grinding plant caused by the silicon dust explosion at Bremanger, Norway, October 1972.

found lying on the floor about 1 m from the pipe with the hole. According to Kjerpeseth (1990) there was strong evidence of the small hole having been made by means of the cutting torch just at the time when the explosion occurred. The interior of the pipe that was perforated had probably not been cleaned prior to the perforation. At the moment of the explosion, part of the plant was closed down due to various repair work. However, the dust extraction system was operating. In view of the high temperature and excessive thermal power of the cutting torch, and not least the fact that it supplied pure oxygen to the working zone, a layer of fine dust on the internal pipe wall may well have become dispersed and ignited as soon as the torch had burned its way through the pipe wall. The blast from the resulting primary silicon dust explosion then raised dust deposits in other parts of the plant into suspension and allowed the explosion to propagate further until it eventually involved the entire silicon grinding building. The grinding plant was not rebuilt after the explosion.

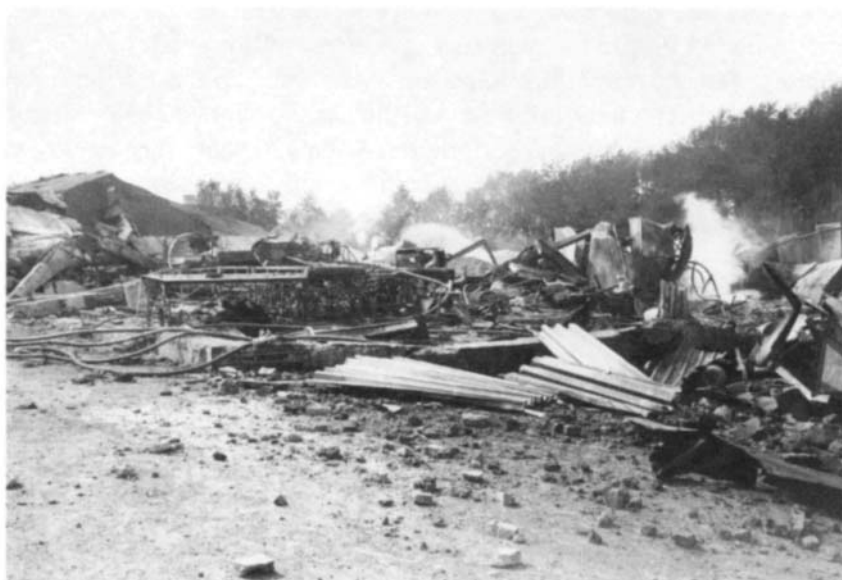
The main source of information concerning the original investigation of the accident is Berg (1989). The explosion occurred during the working hours, just before lunch, while ten workers were in the same building. Five of these lost their lives, two were seriously injured, two suffered minor injuries, whereas only one escaped unhurt. A substantial part of the plant was totally demolished, as illustrated by Figure 5-48.

The premix preparation plant building was completely destroyed. Debris was found up to 75 m from the explosion site. The explosion was followed by a violent fire in the powders left in the ruins of the plant and in adjacent storehouse for raw materials. The explosion occurred when charging the 5.2 m<sup>3</sup> batch mixer, illustrated in Figure 5-49.

**Figure 5–48** Scene of total demolition after aluminum dust explosion in the premix plant of a slurry explosives factory at Gullaug, Norway, in August 1973. From Eckhoff (2003).

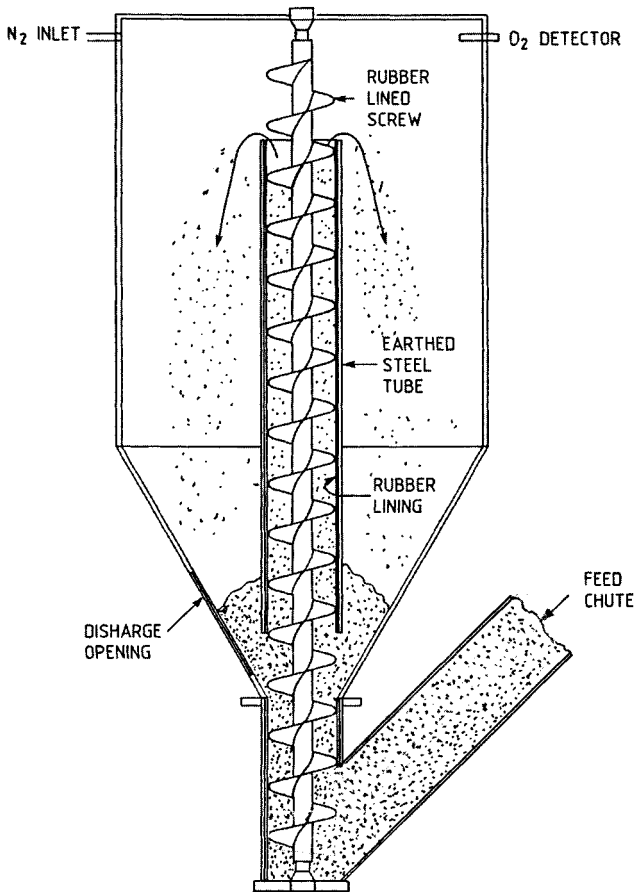
The construction materials of the mixer had been selected so as to eliminate the formation of mechanical sparks. This was probably why both the screw and the internal wall of the surrounding earthed steel tube were lined with rubber.

During operation the 5.2 m<sup>3</sup> vessel was flushed with nitrogen, the concentration of oxygen in the vessel being controlled by a direct-reading oxygen analyzer at the vessel top. According to the foreman's statement, the oxygen content at the moment of explosion was within the specified limit. After the explosion, the heavy central screw part of the mixer, with the mixer end cap, was retrieved about 12 m away from the location of the mixer prior to the explosion. More detailed investigation of the part of the screw that was shielded by the steel tube, revealed that the screw wings had been deformed bi-directionally as if an explosion in the central part had expanded violently both upwards and downwards. This evidence was considered as a strong indication of the explosion having in fact been initiated inside the steel tube surrounding the screw. The blast and

**Figure 5-49** Cross-section of the mixer used for production of dry premix for slurry explosives at Gullaug, Norway, in 1973, From Eckhoff (2003).

flame from this primary explosion, in turn, generated and ignited the dust cloud in the main space inside the mixer. Finally the main bulk of the powder in the mixer was thrown into suspension and brought to ignition when the mixer ruptured, giving rise to a major dust explosion in the workrooms.

The investigation further disclosed that the design of the nitrogen inerting system of the mixer was inadequate. First, the nitrogen flow was insufficient to enable reduction of the average oxygen concentration to the specified maximum level of 10 vol.% within the time allocated. Secondly, even if the flow had been adequate, both the nitrogen inlet and the oxygen concentration probe were located in the upper part of the vessel (see Figure 5–49) which rendered the measured oxygen concentration unreliable as an indicator of the general oxygen level in the mixer. It is highly probable that the oxygen concentration in the lower part of the mixer, and in particular in the space inside the tube surrounding the screw, was considerably higher than the measured value. This explains why a dust explosion could occur in spite of low measured oxygen concentration.

The final central concern of the investigators was identification of the probable ignition source. In the reports from 1973, it was concluded that the primary explosion in the tube surrounding the screw was probably initiated by an electrostatic discharge. However, this conclusion was not qualified in any detail. In more recent years the knowledge about various kinds of electrostatic discharges has increased considerably. It now seems highly probable that the ignition source in the 1973 Gullaug explosion was a propagating brush discharge, brought about by the high charge density that could accumulate on the internal rubber lining of the steel screw and of the steel tube surrounding the screw, because of the earthed electrically conducting backing provided by the screw and the tube.

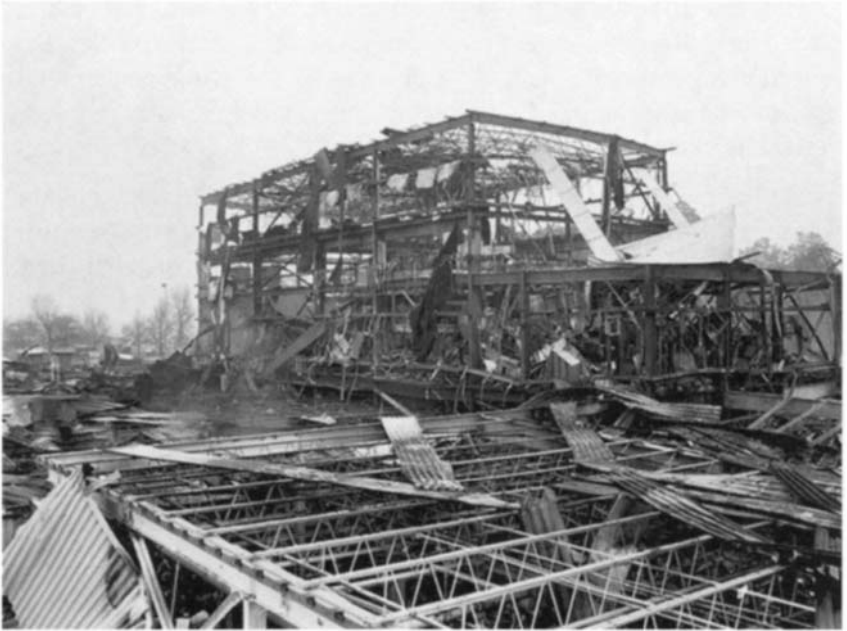
**Figure 5-51** Photo of the West Pharmaceutical Services Inc., production plant in Kinston, North Carolina, USA, after the dust explosion 29 January 2003. From CSB (2003).

The explosion and ensuing fire heavily damaged the compounding section of the Kinston facility. Figure 5–51 shows the extent of the damage. All exterior sheathing on the compounding structure was destroyed and masonry block walls were knocked down. The warehouse collapsed, and the remaining building structure was rendered mostly unusable.

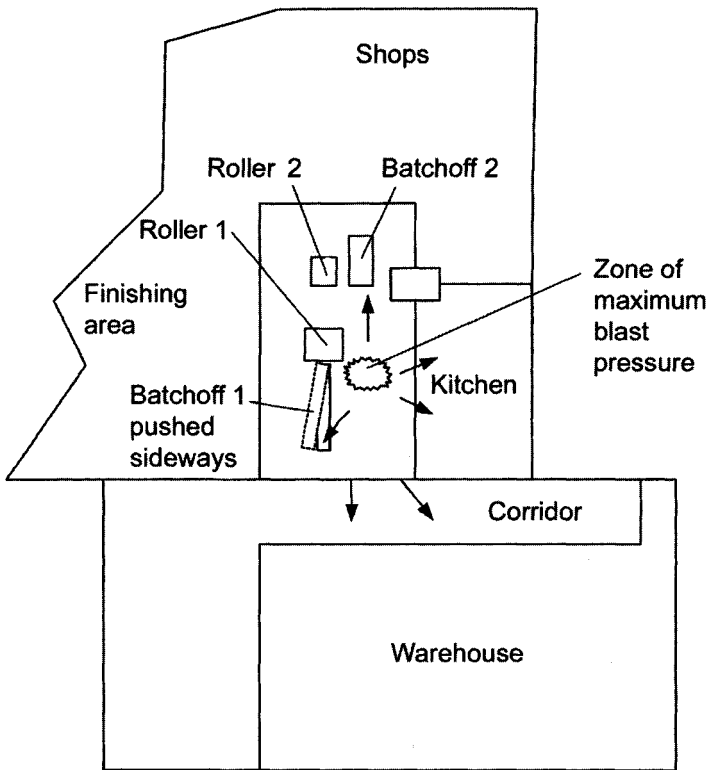
CSB further concluded that the primary, strong explosion occurred in the compounding section of the plant, as illustrated in Figure 5–52. Figure 5–53 shows a photograph of the extensive damage in what was assumed by CSB to be the center of the explosion (zone of maximum blast pressure).

**Figure 5–52** Plan of part of the West Pharmaceutical Services Inc., production plant in Kinston, North Carolina, U.S.A., showing the centre of the dust explosion 29 January 2003. From CSB (2003).

The location of the highest pressure was determined to be close to Roller 1 on the first floor of the three-story compounding section, as indicated in Figure 5–52. Force vectors derived from observed damage to the building and surrounding equipment indicate that the largest pressure developed in the compounding section and emanated spherically outward. CSB investigators also recovered ceiling tiles debris from the suspended roof above the ground floor of the compounding section. Nearly all of the tiles appeared to be burned and splattered on top, but not on the bottom, which had faced the ground floor room below. Furthermore, some of the fluorescent light fixture pans recovered from the Roller 1 area had been flattened from above, as if they had been forcefully driven downward to the concrete floor. These two pieces of evidence give further support to the theory that the explosion occurred within the confined space above the suspended ceiling. Independent quantitative CFD simulations also concluded that the explosion occurred on the first floor of the compounding section, and that the explosion pressure from this area was the source of the extensive blast damage throughout the facility.

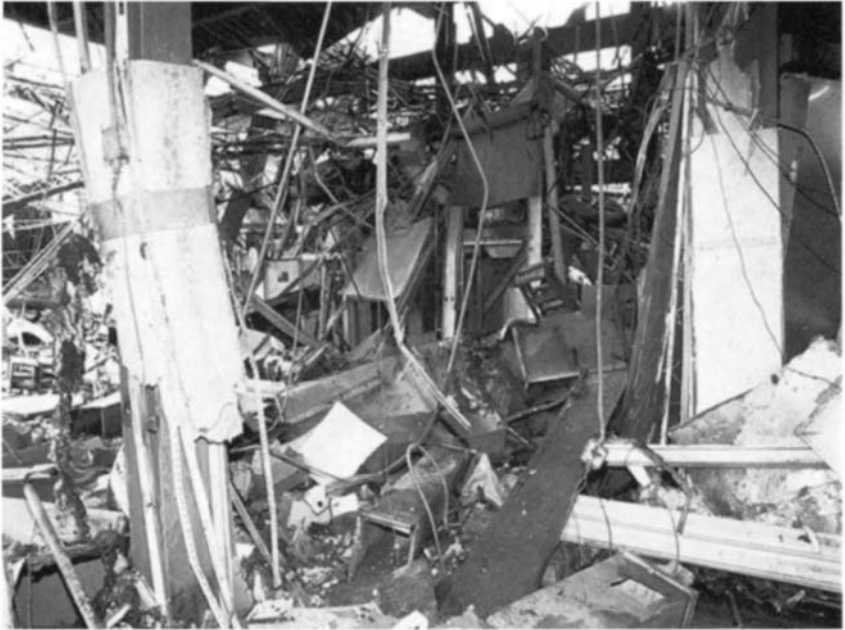
**Figure 5–53** Photograph of what was assumed to be the centre of the dust explosion in the West Pharmaceutical Services Inc., production plant in Kinston, North Carolina, U.S.A., 29 January 2003. From CSB (2003).
