## 5.4 Case Histories of Dust Explosions

### 5.4.1 Motivation for Selection

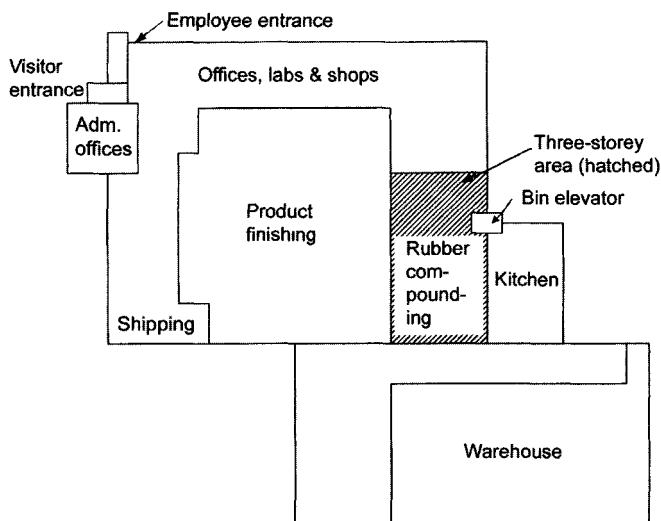
The Kinston plant was located in a light industrial business park adjacent to the regional airport. Two private residences and the local Humane Society shelter were each located about 300 m from the facility. The plant area illustrated in Figure 5-50 was approximately 13500 m<sup>2</sup>, and primarily single story. However; some of the rubber compounding equipment was located in a 18 m high, three storey area, which is hatched in Figure 5-50. The plant housed two main operations, viz. rubber compounding and product finishing. In the finishing process, the compounded rubber was molded and pressed into stoppers and plungers.

**Figure 5-50 Plan of the West Pharmaceutical Services Inc., production plant in Kinston, North Carolina, U.S.A., prior to the dust explosion 29 January, 2003. From CSB (2003).**
