## **Explosives, Pyrotechnics, and Propellants**

### **6.1 Chemical Composition of Some Explosives**

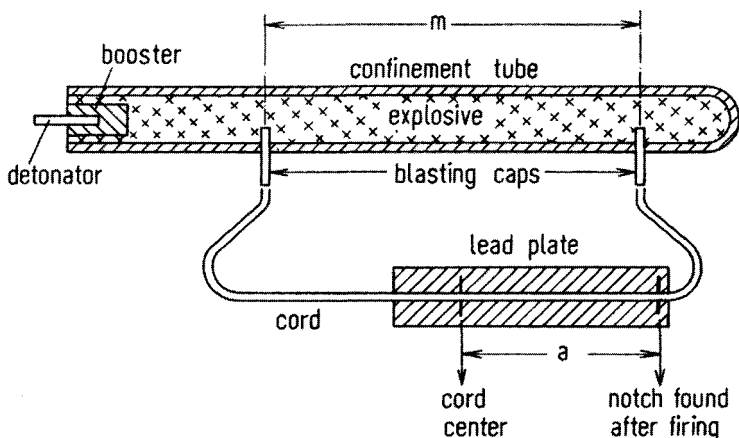
**Figure 6-1 Dautriche Method for Measurement of detonation velocities in explosives. From Meyer (1987).**

The sample of the explosive to be tested is placed in a confinement tube, which may or may not be surrounded by a steel sleeve. The part of the sample along which the detonation velocity is to be measured, is defined by two blasting caps. The ends of a piece of detonating cord of known detonation velocity is connected to the blasting caps, and the cord is passed across a lead plate as indicated in the figure. The detonation wave in the test sample is initiated by the detonator/booster at the upstream end of the test tube, and a steady detonation wave front starts to travel along the confinement tube. As soon as this wave hits the first blasting cap, a second detonation wave is instantaneously initiated at the end of

The Dautriche method for determination of detonation velocities of explosives, as described by Meyer (1987), is illustrated in Figure 6–1.

$$m/D_{\text{sample}} = 2a/D_{\text{cord}} \quad (6.1)$$

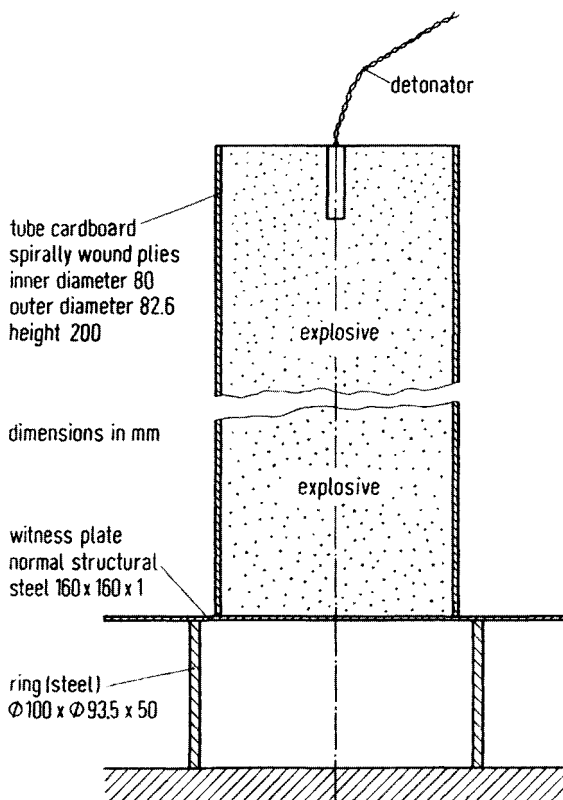
The explosive sample is placed into a 200 mm-long cardboard sleeve of 80 mm internal diameter and wall thickness between 1.3 and 1.4 mm. The bottom end of the sleeve is sealed by a thin cardboard disk, which is glued into position. Because the cap sensitivity can be influenced by the density of the sample under test, the density is determined by weighing. The cardboard test sleeve with the test sample is placed upright onto a steel plate of 1 mm thickness, resting on a steel ring of 50 mm height, inside diameter 100 mm, and wall thickness 3.5 mm. A standardized test fuse is inserted at the top of the sample and initiated. If a proper detonation wave is initiated in the sample, a sharp circular hole is cut out of the steel plate. If no change in the condition of the steel plate, or only denting with or without fissure is observed, this is classed as a non-detonation.

**Figure 6-2 The cap sensitivity test for classifying explosives with regard to the explosion hazard that they represent when being transported. From Meyer (1987).**

In this case, the objective of the test is to determine the response of a sample of the explosive to a standardized detonating cap. The results are used to determine the classification of the explosive as a transport hazard. According to Meyer (1987), the test method illustrated in Figure 6-2 has been used in Germany.

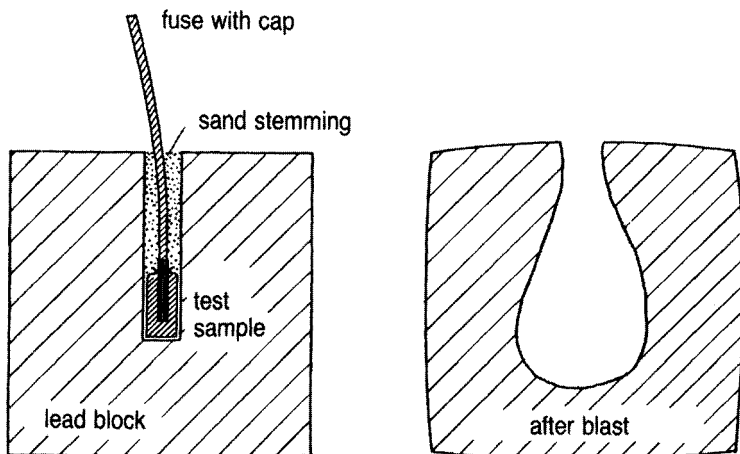
A sample of 10 g of the test material, wrapped in tinfoil, is introduced into a central bore hole (125 mm deep, 25 mm diameter) in a massive cylinder of soft lead, of height and diameter equal to 200 mm. A standardized blasting cap with an electric primer is introduced into the center of the explosive charge, and the remaining free space is filled with quartz sand of standard grain size. After the explosion, the volume of the resulting

**Figure 6-3 The Trauzl lead block test for comparing the strength of explosives.**  
**From Meyer (1987).**

bulge is determined by filling it with water. The volume of the original cavity is deducted from the result obtained. 10g of picric acid may be used as a standard explosive charge for comparison.

The Trauzl lead block test is a comparative method for the determination of the strength of an explosive. The principle of the test is illustrated in Figure 6-3.

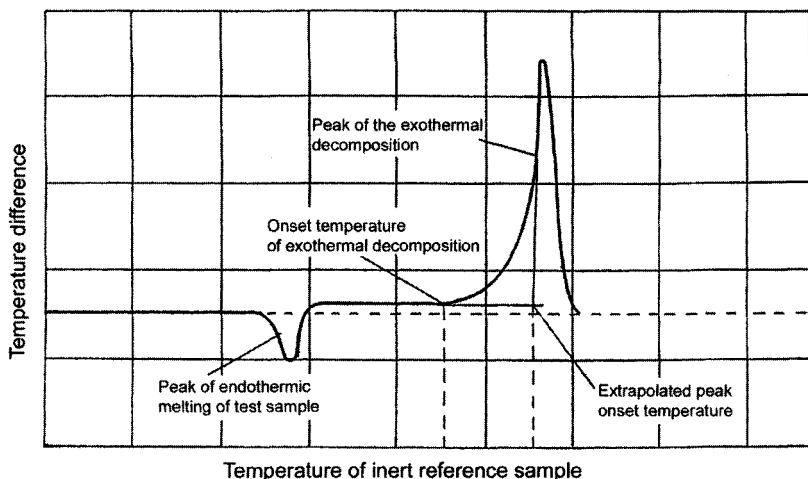
**Figure 6-4** Example of result of DTA test for the decomposition temperature of explosives, propellants and pyrotechnics. From CENELEC (1997).

CENELEC (1997) defines the decomposition temperature as the lowest temperature at which a given quantity of the material tested ignites in a carefully standardized differential thermal analysis (DTA) test. The basic principle of DTA is that the sample under test and a sample of the same size of an inert material are heated in parallel and the temperature difference between the two samples recorded continuously. The sample size is in the range 0.1 and 0.5 g, whereas the heating rate shall not exceed 5°C/min. Figure 6-4 shows an example of the result of a DTA test. In this particular case, the first recorded difference between the temperature of the test sample and the inert reference sample is a modest negative peak due to endothermic melting of the test sample. However, as the temperature rises further, the major exothermal peak of the decomposition reaction appears. The decomposition temperature in this test is defined as the "extrapolated peak initial temperature," i.e., the reference sample temperature at which the steepest tangent to the rising part of the decomposition peak intersects with the base line, as indicated in Figure 6-4.

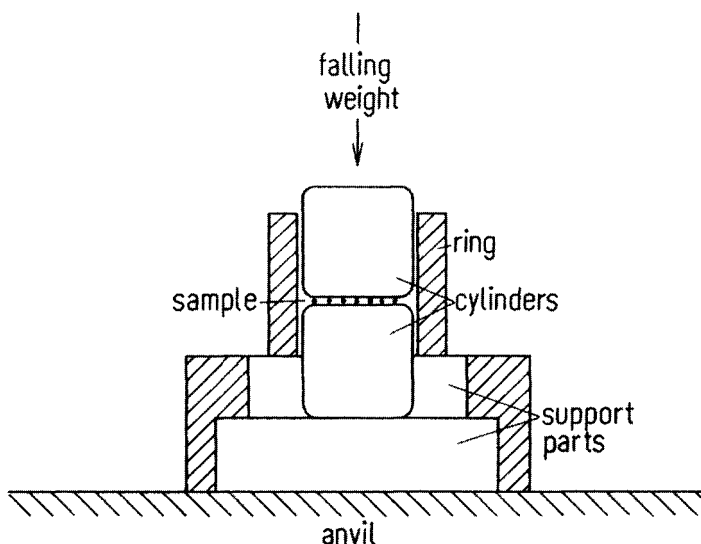
The samples of the explosives are subjected to the action of falling weights of different masses. The parameter to be determined is the height

**Figure 6-5** Illustration of the drop hammer impact sensitivity test. From Meyer (1987).

of fall, for one specific weight mass, at which a sufficient amount of impact energy is transmitted to the sample for it to decompose or to explode. According to Meyer (1987), the U.S. standard procedures are:

The sensitivity to impact of solid, liquid, or gelatinous explosives is tested by the drop hammer method. The principle of this method is illustrated in Figure 6-5.

In the U.S. Bureau of Mines test, a sample of 0.020 g of the explosive is tested, using a fixed dropping mass, usually 2 kg. The result of the test is the minimum height at which at least one of 10 repeated trials results in explosion. In the U.S. BM apparatus, the explosives sample is held between two flat, parallel hardened steel surfaces, as illustrated in Figure 6-5.

In the case of the U.S. BM apparatus (illustrated in Figure 6-5), the same basic procedure as used with solids is applied with the following modifications:

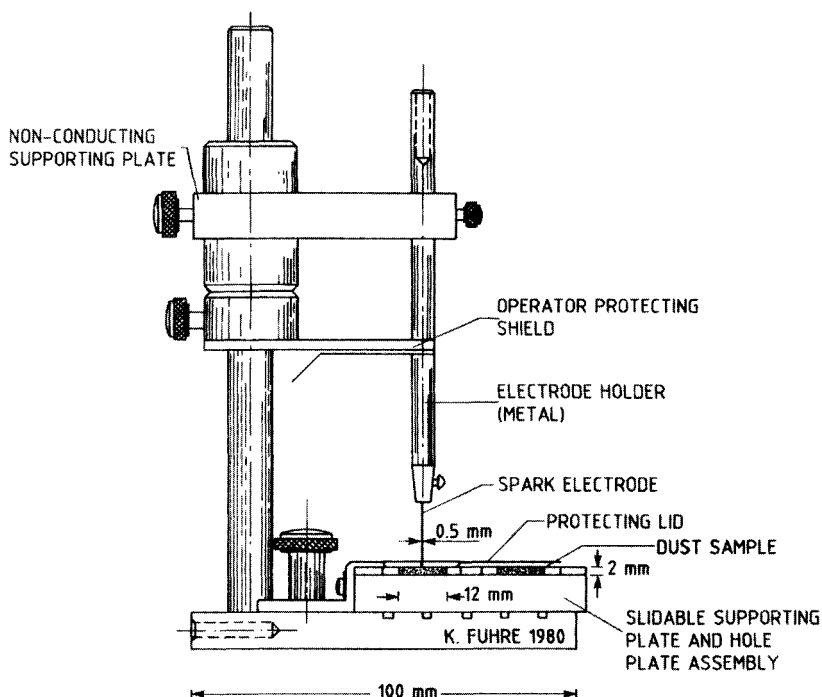
The dust/powder is poured gently into the disc-shaped cavities formed by the slidable supporting plate/hole plate assembly and excess dust is removed by a scraper. Plane, circular dust/powder samples of thickness 2 mm and diameter 12 mm are thus obtained. The metal bottom of the

**Figure 6-6 Cross-section of Nordtest (1982) apparatus for determination of electric spark sensitivity of layers of explosives, pyrotechnics and propellants.**

cavities acts as the earthed one of the two electrodes forming the spark gap. A thin tungsten wire pointing downwards towards the dust/powder layer and with its tip just above the dust/powder surface, acts as the second high voltage electrode.

The test apparatus is illustrated in Figure 6–6.

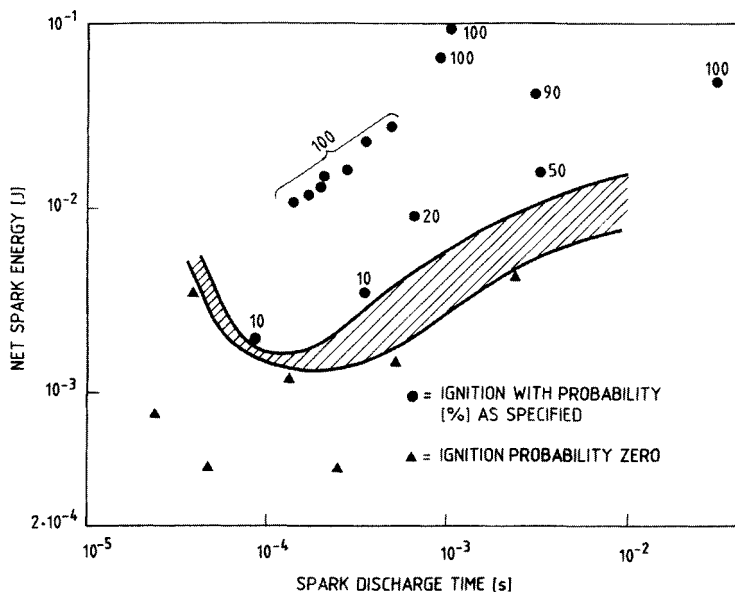
**Figure 6-7** Electric spark ignition sensitivity profile of a given pyrotechnics product as determined by the Nordtest (1982) method.

The minimum electric spark ignition energy, defined as the net spark energy yielding an ignition frequency of 5%, is determined for various

spark discharge times or durations  $\Delta t$ . The ultimate result of the test is an electric spark sensitivity profile  $E_{\min}(\Delta t)$ , as illustrated by the hatched area in Figure 6-7.

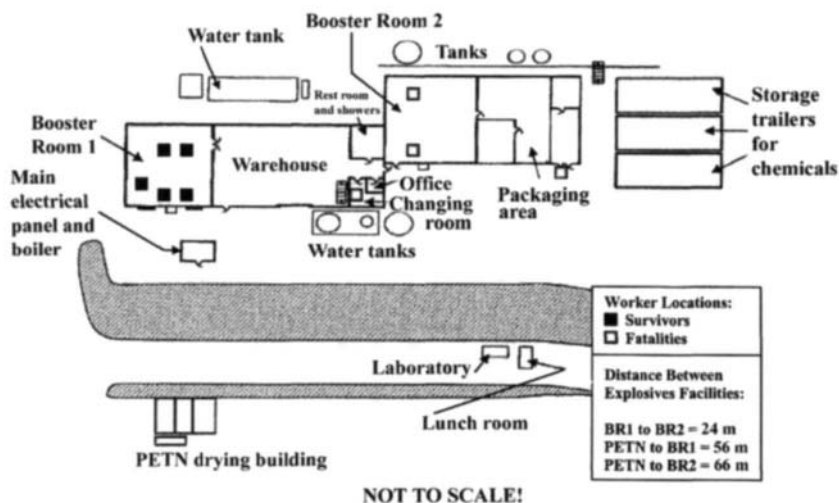
**Figure 6–8** Approximate plan of the Sierra Chemical Company Kean Canyon plant east of Reno near Mustang, Nevada, USA. From CSB (1998).

The boosters were filled in the two Booster Rooms indicated in the figure. The primary explosives used in the base mix were TNT (2,4,6 trinitrotoluene), PETN (pentaerythritol tetranitrate), and a mixture of TNT and RDX (hexahydro 1,3,5 trinitro 1,3,5 triazine). Pentolite was a mix of TNT and PETN.

The Sierra Kean Canyon plant manufactured explosive boosters, mixed custom flux for gold smelting operations, and repackaged bulk soda ash for sale to the mining industry. When initiated by a blasting cap or detonation cord, boosters provide the added energy necessary to detonate less sensitive blasting agents or other high explosives. The boosters manufactured at the Kean Canyon plant consisted of a base mix and a second explosive mix, called Pentolite, both of which were poured into cardboard cylinders (see Section 6.2.2.2). The operators working in the plant were responsible for the preparation of the explosive mixtures, the operation of the mixing pots, and the pouring of the mixtures into the cardboard cylinders. Figure 6–8 gives an approximate outline of the part of the plant that was demolished by the accidental explosion.

Most probably the first explosion was initiated in a mixing pot in Booster Room 2 (see Figure 6–8), when an operator who had left about 25–50 kg of base mix in his mixing pot the day before, turned on the mixing stirrer motor of the pot the next morning. During the evening and night the mix had stratified and solidified, and the explosion initiation occurred when the bottom of the mixer blade, which was embedded in the solidified explosives mix in the pot, forced the explosive material by impact, shearing, or friction against the pot wall. Alternatively, explosive material was pinched between the mixer blade and the pot wall, causing the initial detonation in the pot. The shock wave from this initial detonation then instantaneously detonated the other several thousand kg of explosives in the Booster Room 2, leading to the first main explosion that completely demolished Booster Room 2, and also the rest of the building. Only three walls were left of Booster Room 1, as indicated in Figure 6–9, whereas Booster Room 2 was completely levelled with the earth, as can be seen in Figure 6–10.

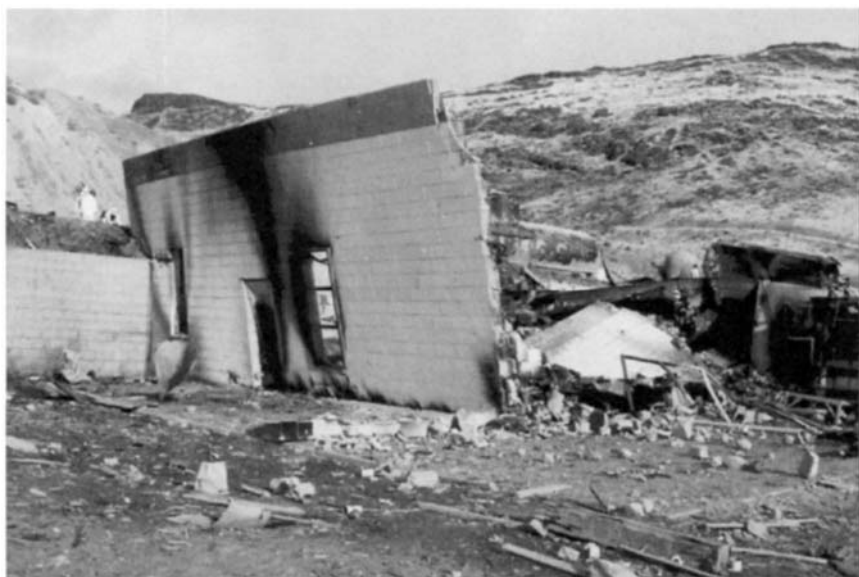
**Figure 6–9** Remains of Booster Room 1 of the Sierra Chemical Company Kean Canyon plant east of Reno near Mustang, Nevada, USA, after explosives mix explosion in 1998. From CSB (1998).

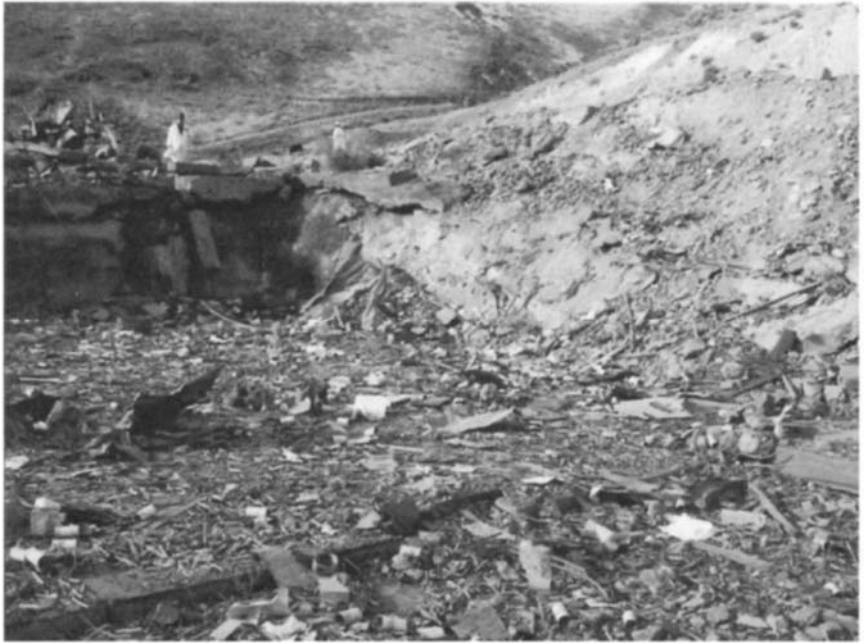
**Figure 6-10** Remains of Booster Room 2 of the Sierra Chemical Company Kean Canyon plant east of Reno near Mustang, Nevada, USA, after explosives mix explosion in 1998. From CSB (1998).

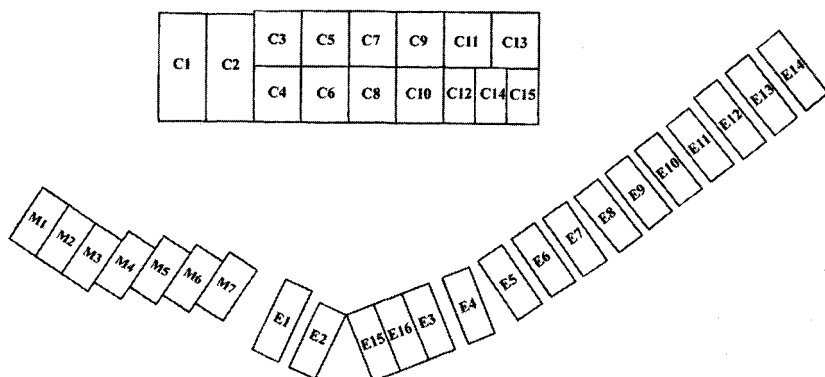
**Figure 6-11 Layout of the pyrotechnics storage premises of the company S.E. Fireworks (SEF) in the city of Enschede in the Netherlands in 2000.**  
Based on figure from Weerheijm et al. (2002).

The facility consisted of a central storage building containing 14 storage cells (C2-C15), 7 prefabricated garage boxes (M1-M7), and 14 ISO containers (E1-E14).

The layout of the pyrotechnics storage facility prior to the fire/explosion is illustrated in Figure 6–11.

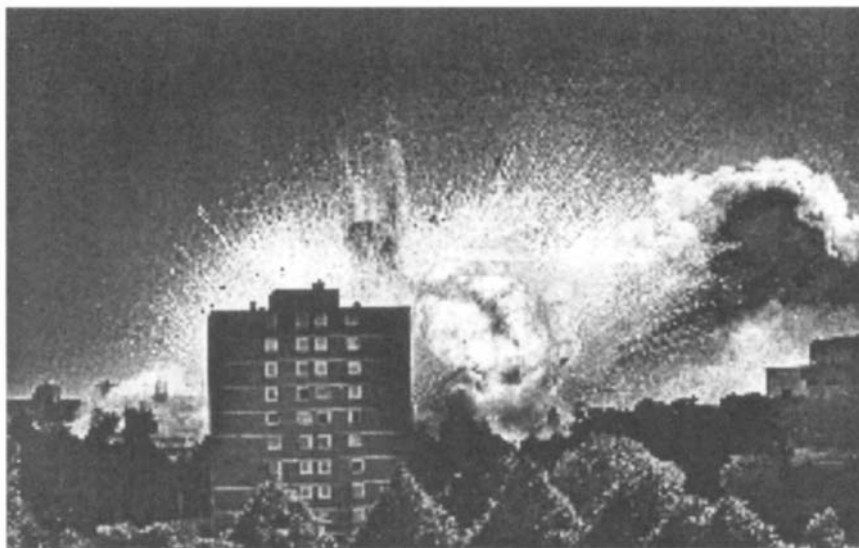
**Figure 6-12** Photograph, taken at a distance of 600 m, of fireball created by the final major explosion on the pyrotechnics storage premises of the company S.E. Fireworks (SEF) in the city of Enschede in the Netherlands, in May 2000. From Bruyn et al. (2002).

Figure 6–12 shows the fire ball from the final explosion from a distance of about 600 m, whereas Figure 6–13 is a top view of the completely demolished explosion area, with search sections taped out for the forensic investigation.

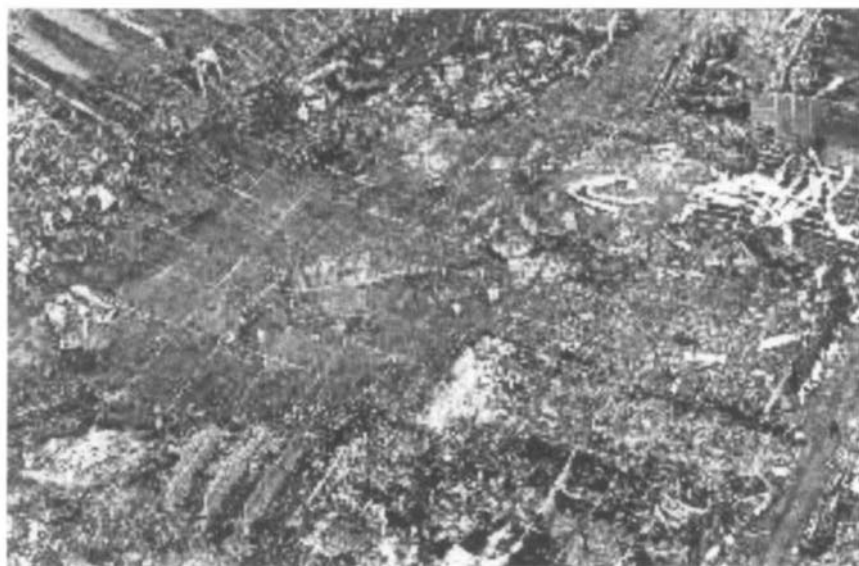
**Figure 6-13** Top view photograph of the explosion area after the final major explosion on the pyrotechnics storage premises of the company S.E. Fireworks (SEF) in the city of Enschede in the Netherlands, in May 2000. From Bruyn et al. (2002).
